**Environmental Condition of Property
to Support Hawaii Public-Private
Venture Housing Phase 4
Marine Corps Base Hawaii Housing Areas:
Mololani, Pa Honua 3, & Ulupau
KANEEOHE BAY, HAWAII**

August 2007

**Environmental Science International
56 Oneawa Street, Suite 103
Kailua, HI 96734**

Contract Number N62742-06-D-1891, CTO 0002

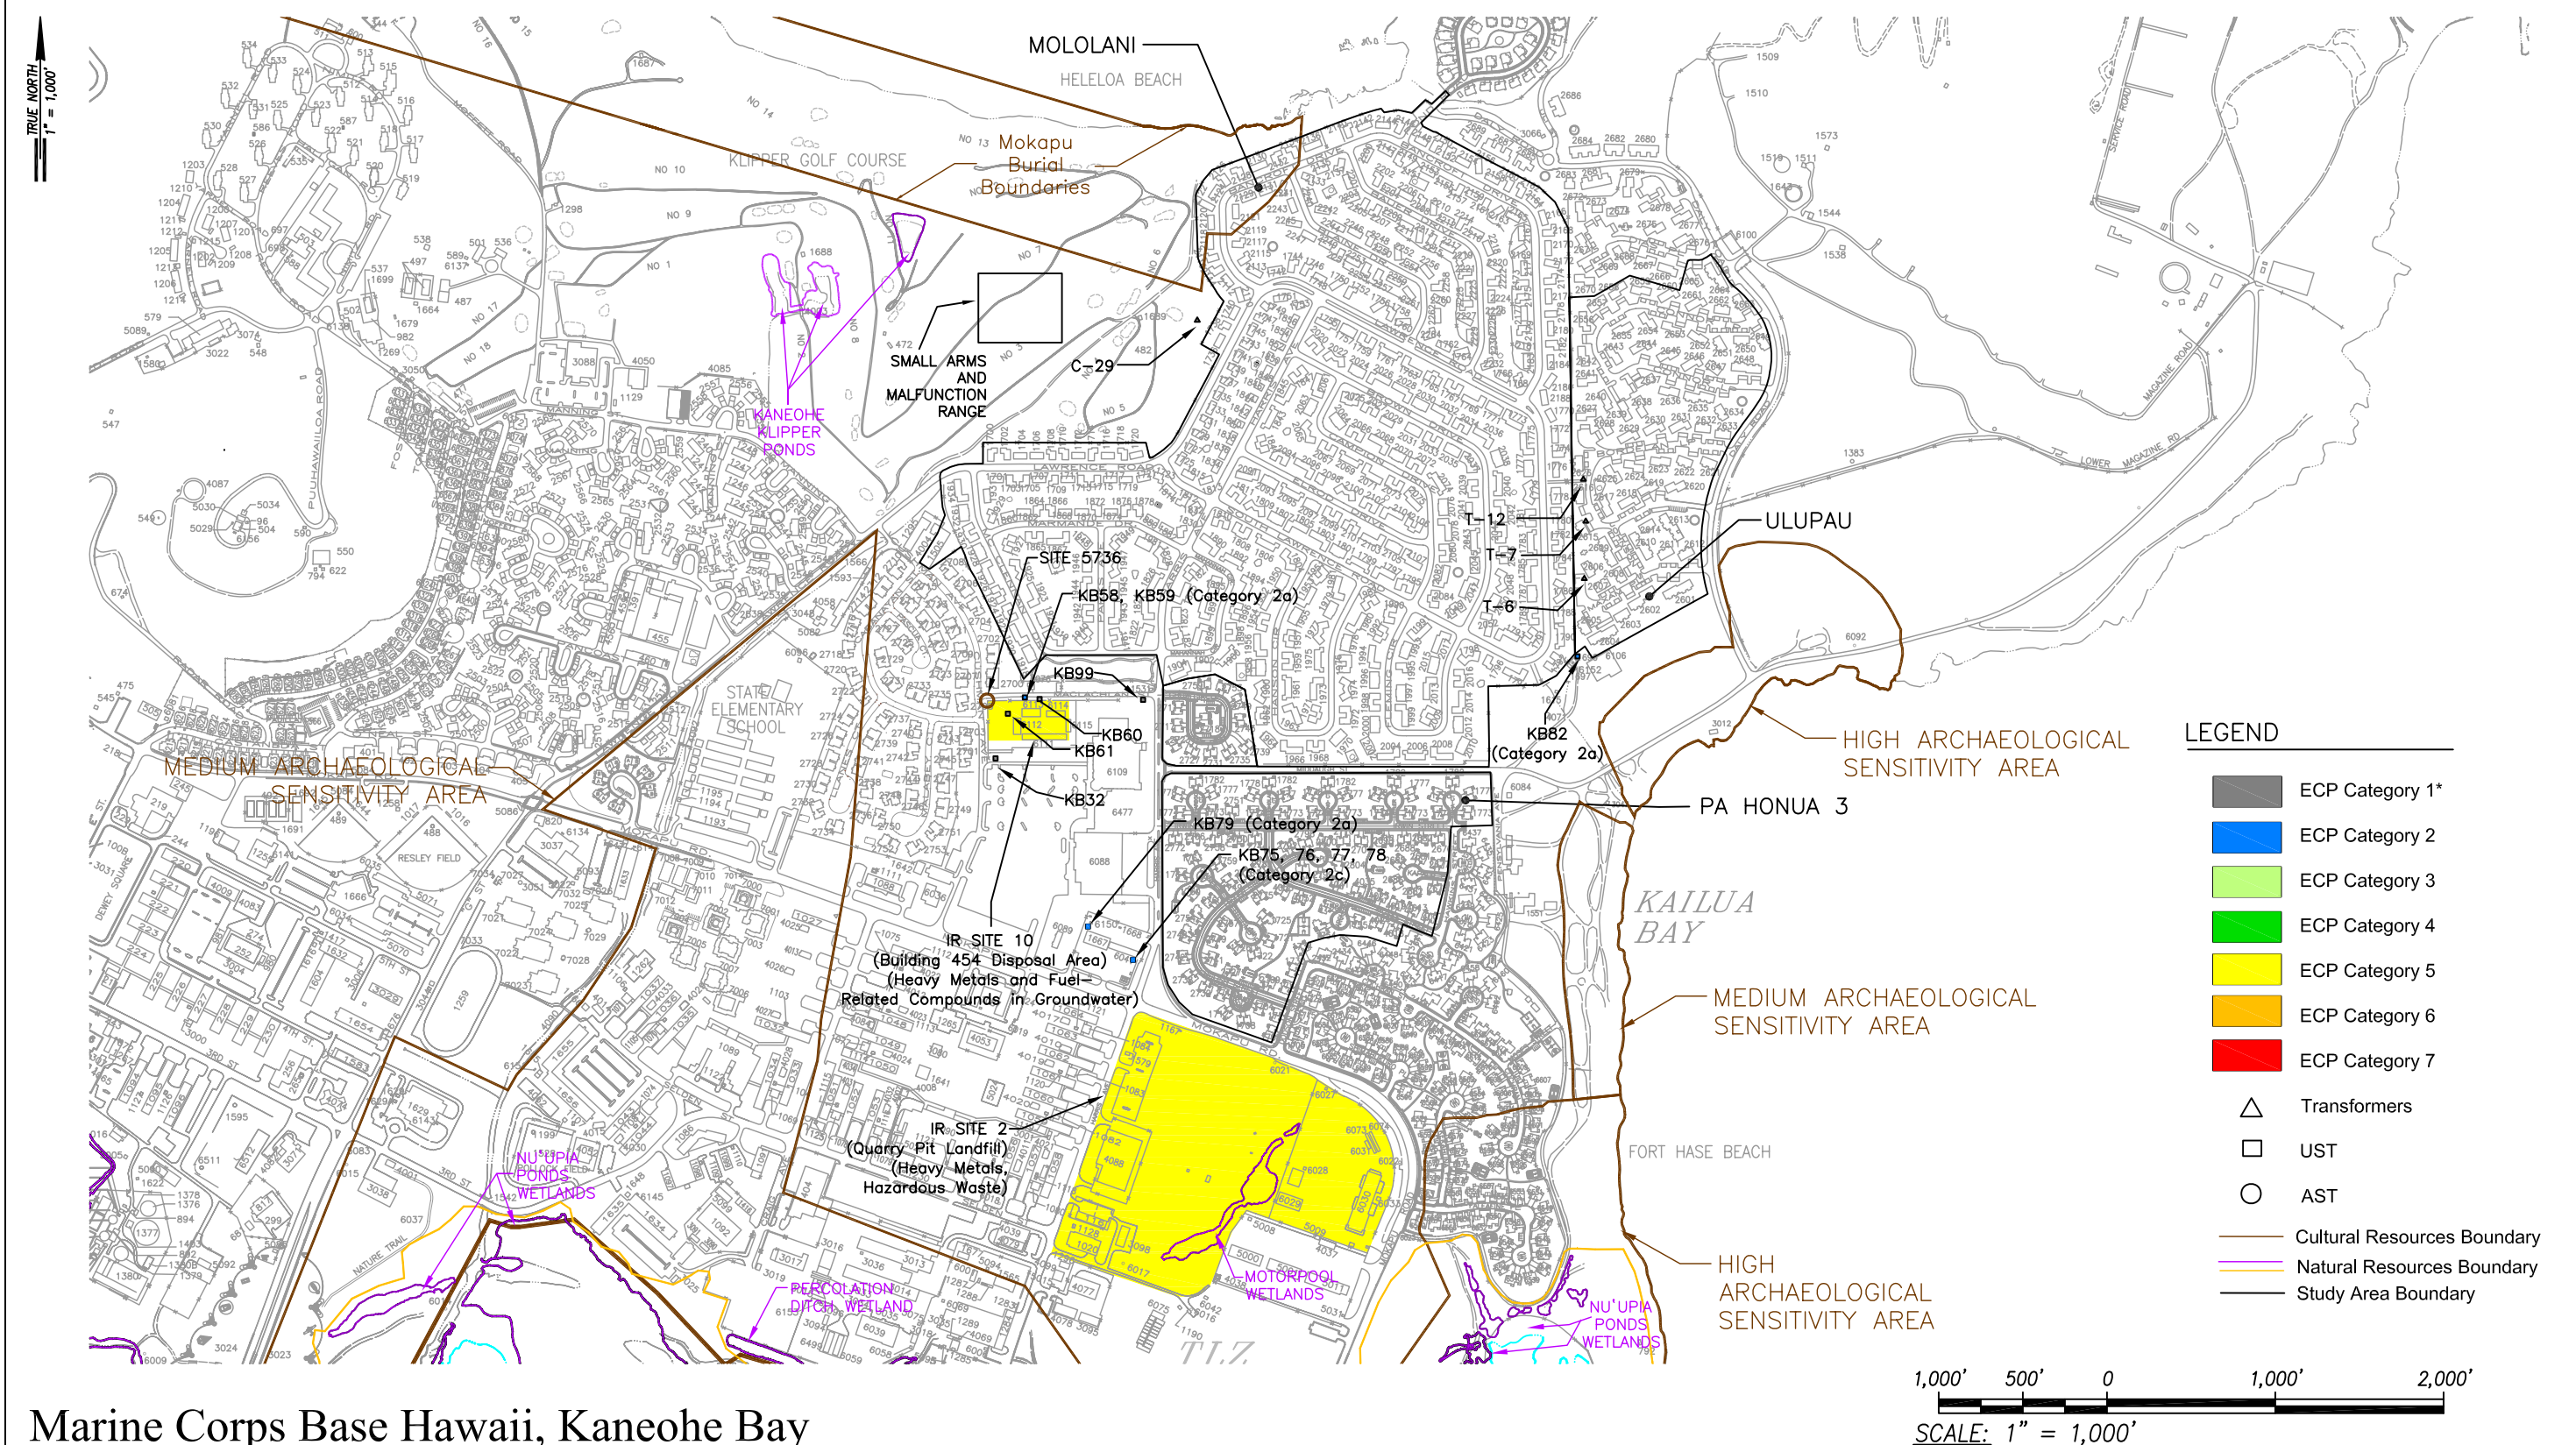
ENVIRONMENTAL CONDITION OF PROPERTY		
HAWAII PPV HOUSING PHASE 4 SUMMARY ENVIRONMENTAL CONDITION OF PROPERTY		FIGURE 6-1

A complete summary of the findings of concern requiring notification for the Subject Property along with the ECP category for each item is provided in Table 6-1. The locations of significant findings (Category 1 and higher) are shown on Figure 6-1.

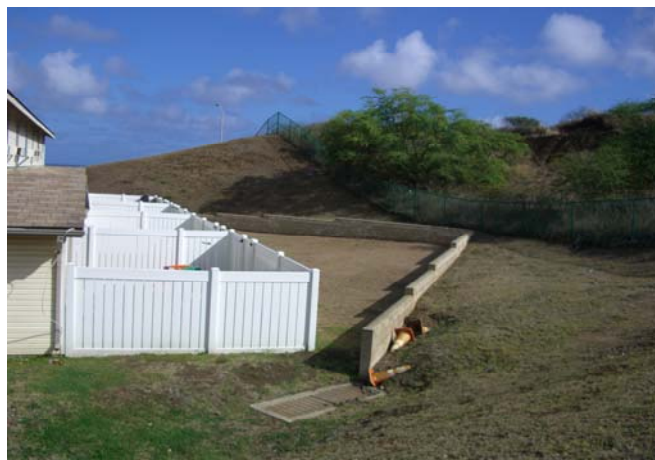
Photo2	View of the drainage culvert and surface drain located south of Bldg. 2686. Bldg. 2686 is visible in the background (left), with the Ulupau crater extending to the right.
--------	--

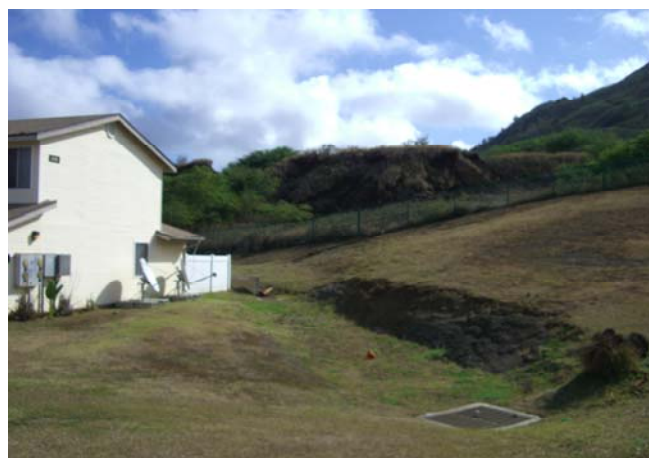
Photo3

View of the drainage ditch, facing northwest toward Heleloa beach. The discharge location located downgradient and to the west of the surface drain shown in photo2.
